# 12 Carn Dearg Road Claggan Fort William PH33 6QB

Inspected on: 9th November 2022

Samuel & Partners First Surveyors Scotland First Floor, 20 High Street FORT WILLIAM PH33 6AT

- 1. Property Questionnaire
- 2. Single Survey
- 3. Mortgage Valuation
- 4. Energy Report

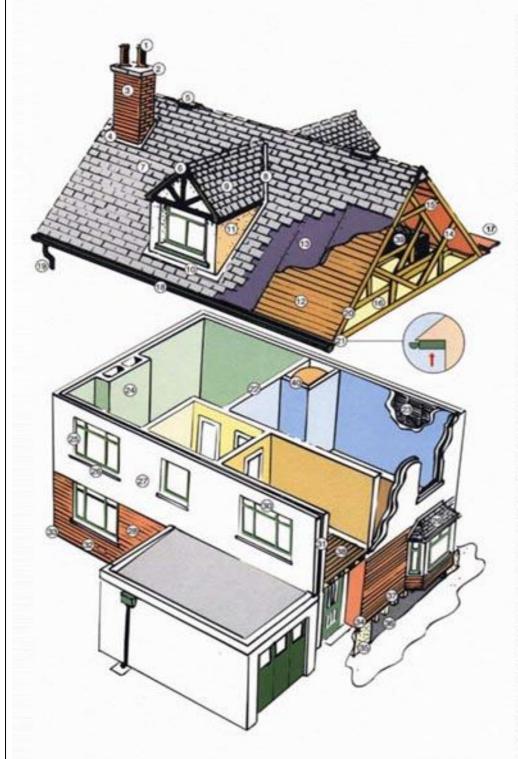
#### Sectional Diagram showing elements of a typical house

Reference may be made in this report to some or all of the above component parts of the property. This diagram may assist you in locating and understanding these items.

- 1) Chimney pots
- 2) Coping stone
- 3 Chimney head
- (4) Flashing
- (5) Ridge ventilation
- (6) Ridge board
- 7 Slates / tiles
- 8 Valley guttering
- 9 Dormer projection
- (10) Dormer flashing
- (11) Dormer cheeks
- (12) Sarking
- 13 Roof felt
- (14) Trusses
- (15) Collar
- (16) Insulation
- (17) Parapet gutter
- (18) Eaves guttering
- (19) Rainwater downpipe
- 20) Verge boards /skews
- (21) Soffit boards
- 22) Partition wall
- (23) Lath / plaster
- (24) Chimney breast
- (25) Window pointing
- (26) Window sills
- (27) Rendering
- 28) Brickwork / pointing
- (29) Bay window projection
- (30) Lintels
- (31) Cavity walls / wall ties
- 32) Subfloor ventilator
- (33) Damp proof course
- (34) Base course
- 35) Foundations
- 36) Solum
- (37) Floor joists
- (38) Floorboards
- (39) Water tank
- (40) Hot water tank
