YOUR ONESURVEY HOME REPORT

73 Lochaber Road
Fort William
PH33 6TX

SINGLE SURVEY

Single Survey

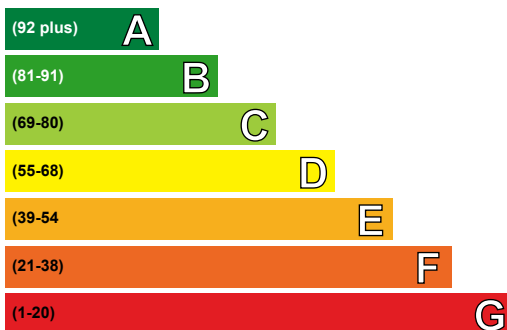
Very energy efficient - lower running costs

Not energy efficient - higher running costs

Current	Potential
61	78

The potential rating shows the effect of undertaking all of the improvement measures listed within your recommendations report.

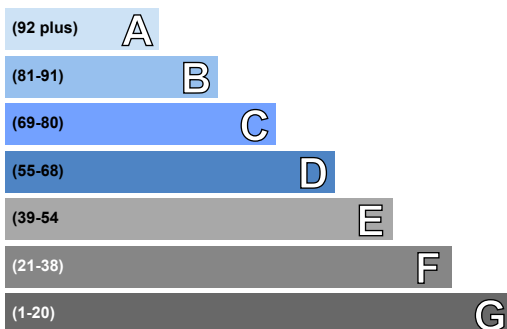
Very environmentally friendly - lower CO₂ emissions

Not environmentally friendly - higher CO₂ emissions

Current	Potential
53	71
