Home Report

Steall Camaghael Fort William PH33 7NF

Prepared by:
Samuel & Partners
First Surveyors Scotland
First Floor
20 High Street
FORT WILLIAM
PH33 6AT

Home Report Index

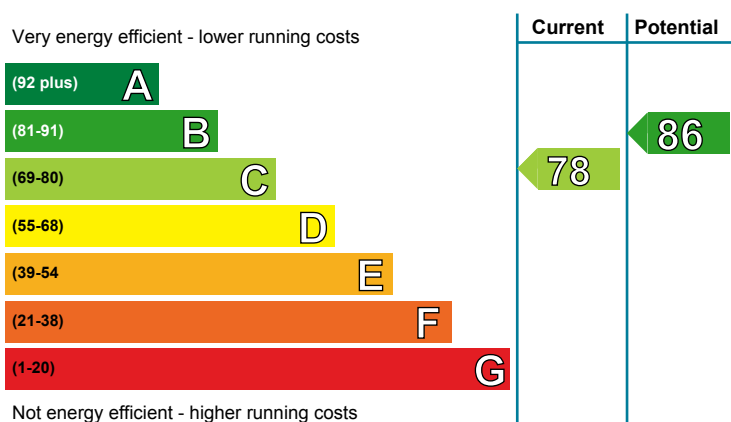
Energy Efficiency Rating

This graph shows the current efficiency of your home, taking into account both energy efficiency and fuel costs. The higher this rating, the lower your fuel bills are likely to be.

Your current rating is **band C (78)**. The average rating for EPCs in Scotland is **band D (61)**.

The potential rating shows the effect of undertaking all of the improvement measures listed within your recommendations report.
