# Home Report

## Rosearden Lochyside Fort William PH33 7NX

Inspected on: 13<sup>th</sup> November 2024

**Prepared by:**  
Samuel & Partners  
First Surveyors Scotland  
First Floor  
20 High Street  
FORT WILLIAM  
PH33 6AT

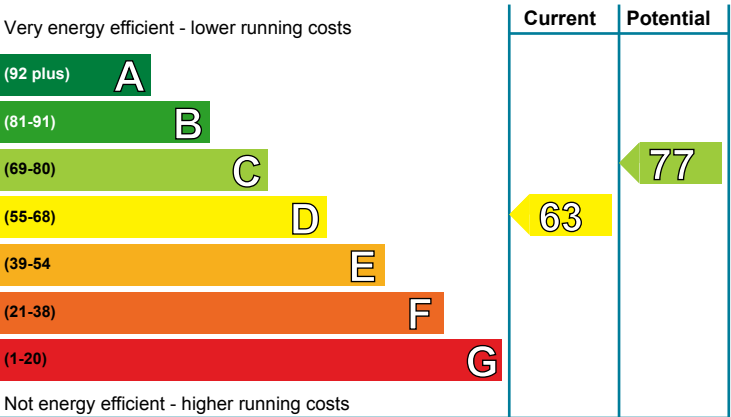
### Energy Efficiency Rating

This graph shows the current efficiency of your home, taking into account both energy efficiency and fuel costs. The higher this rating, the lower your fuel bills are likely to be.
