Home Report

4 Sutherland Avenue Upper Achintore Fort William PH33 6JT

Inspected on: 12th August 2025

Prepared by:
Samuel & Partners
First Surveyors Scotland
First Floor
20 High Street
FORT WILLIAM
PH33 6AT

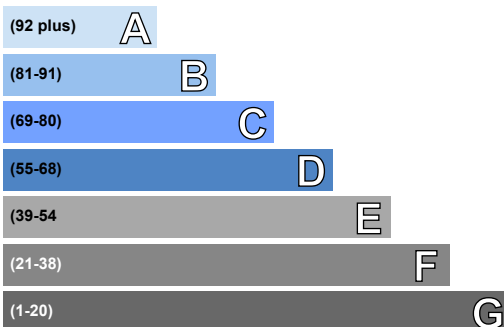
Very environmentally friendly - lower CO₂ emissions

Not environmentally friendly - higher CO₂ emissions

Current	Potential
75	86
