Home Report

12 Morven Place Fort William PH33 6HY

Prepared by:
Samuel & Partners
First Surveyors Scotland
First Floor
20 High Street
FORT WILLIAM
PH33 6AT

1. Property Questionnaire
2. Single Survey
3. Mortgage Valuation
4. Energy Report

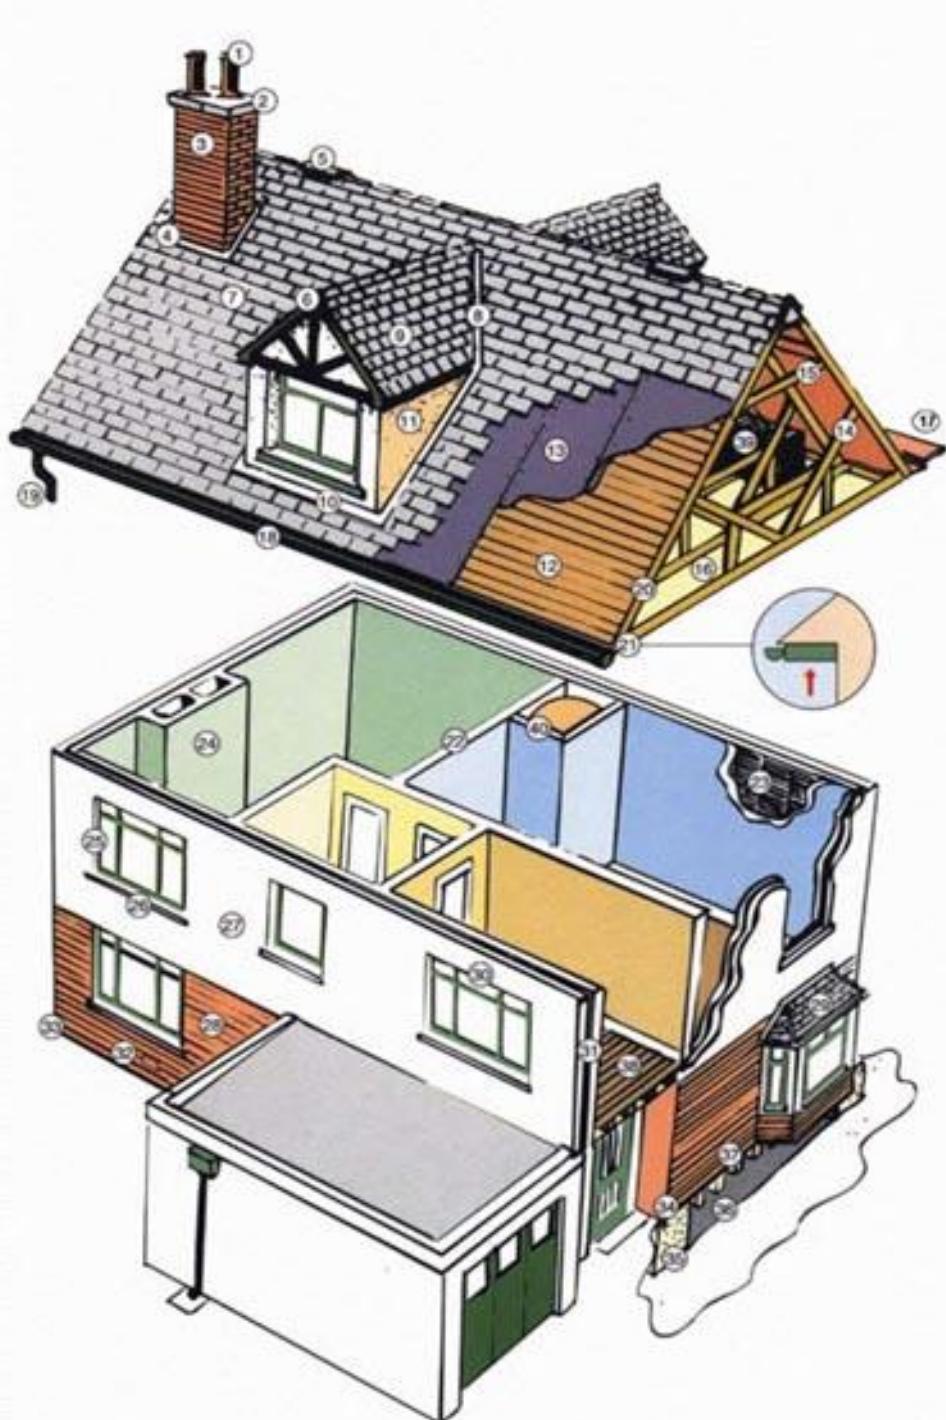
Sectional Diagram showing elements of a typical house

- 1 Chimney pots
- 2 Coping stone
- 3 Chimney head
- 4 Flashing
- 5 Ridge ventilation
- 6 Ridge board
- 7 Slates / tiles
- 8 Valley guttering
- 9 Dormer projection
- 10 Dormer flashing
- 11 Dormer cheeks
- 12 Sarking
- 13 Roof felt
- 14 Trusses
- 15 Collar
- 16 Insulation
- 17 Parapet gutter
- 18 Eaves guttering
- 19 Rainwater downpipe
- 20 Verge boards / skewers
- 21 Soffit boards
- 22 Partition wall
- 23 Lath / plaster
- 24 Chimney breast
- 25 Window pointing
- 26 Window sills
- 27 Rendering
- 28 Brickwork / pointing
- 29 Bay window projection
- 30 Lintels
- 31 Cavity walls / wall ties
- 32 Subfloor ventilator
- 33 Damp proof course
- 34 Base course
- 35 Foundations
- 36 Solum
- 37 Floor joists
- 38 Floorboards
- 39 Water tank
- 40 Hot water tank

Reference may be made in this report to some or all of the above component parts of the property. This diagram may assist you in locating and understanding these items.
