# Home Report

**15 Lochy Road  
Inverlochy  
Fort William  
PH33 6NJ**

**Prepared by:**  
Samuel & Partners  
First Surveyors Scotland  
First Floor  
20 High Street  
FORT WILLIAM  
PH33 6AT

# Home Report Index

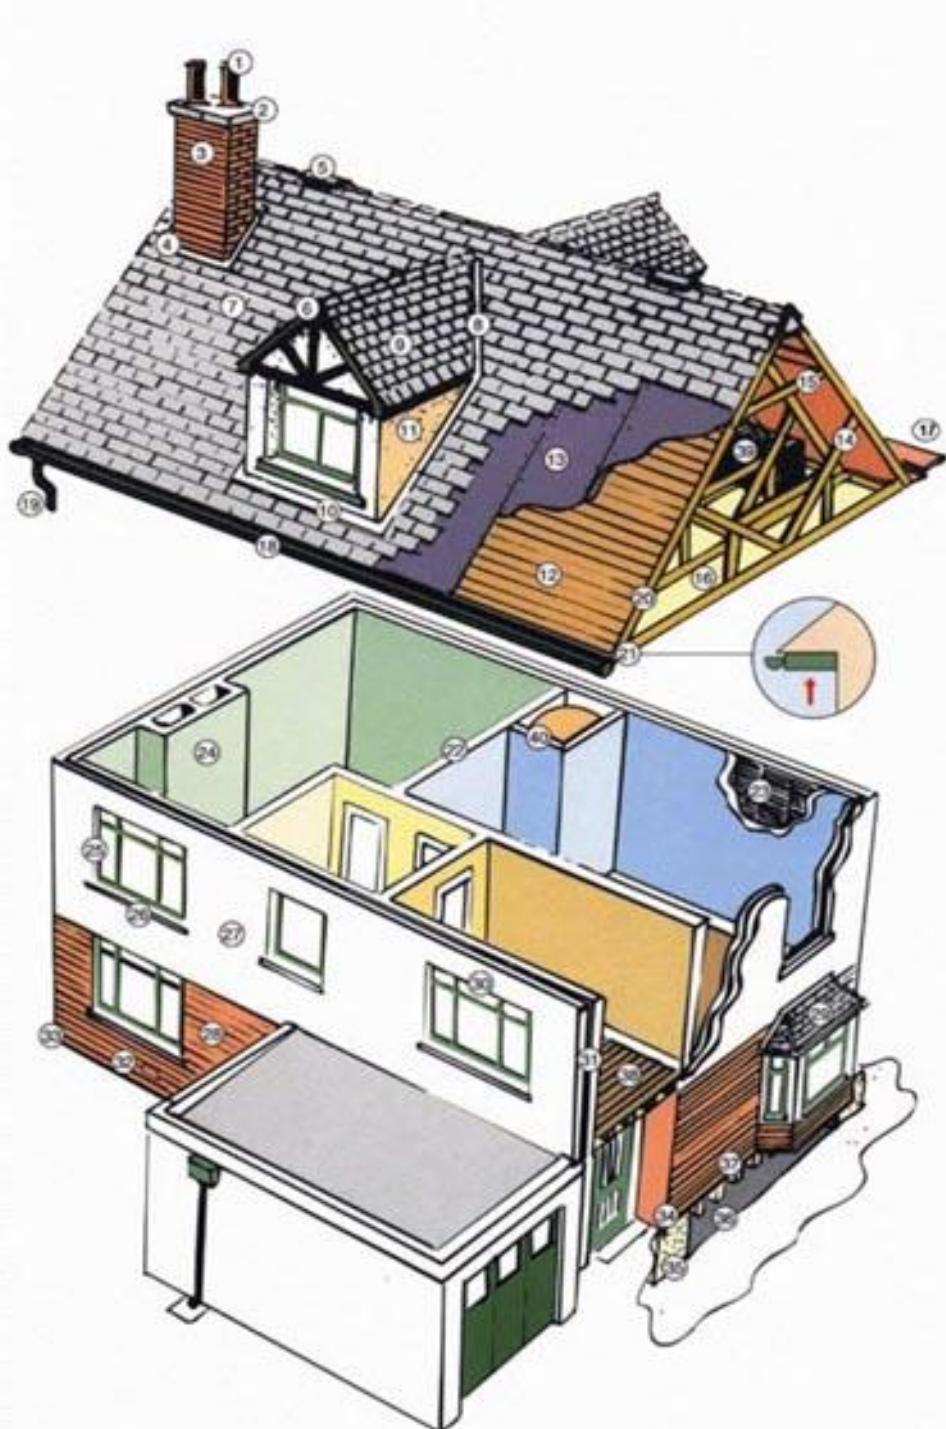
## Sectional Diagram showing elements of a typical house

- 1 Chimney pots
- 2 Coping stone
- 3 Chimney head
- 4 Flashing
- 5 Ridge ventilation
- 6 Ridge board
- 7 Slates / tiles
- 8 Valley guttering
- 9 Dormer projection
- 10 Dormer flashing
- 11 Dormer cheeks
- 12 Sarking
- 13 Roof felt
- 14 Trusses
- 15 Collar
- 16 Insulation
- 17 Parapet gutter
- 18 Eaves guttering
- 19 Rainwater downpipe
- 20 Verge boards / skews
- 21 Soffit boards
- 22 Partition wall
- 23 Lath / plaster
- 24 Chimney breast
- 25 Window pointing
- 26 Window sills
- 27 Rendering
- 28 Brickwork / pointing
- 29 Bay window projection
- 30 Lintels
- 31 Cavity walls / wall ties
- 32 Subfloor ventilator
- 33 Damp proof course
- 34 Base course
- 35 Foundations
- 36 Solum
- 37 Floor joists
- 38 Floorboards
- 39 Water tank
- 40 Hot water tank

Reference may be made in this report to some or all of the above component parts of the property. This diagram may assist you in locating and understanding these items.

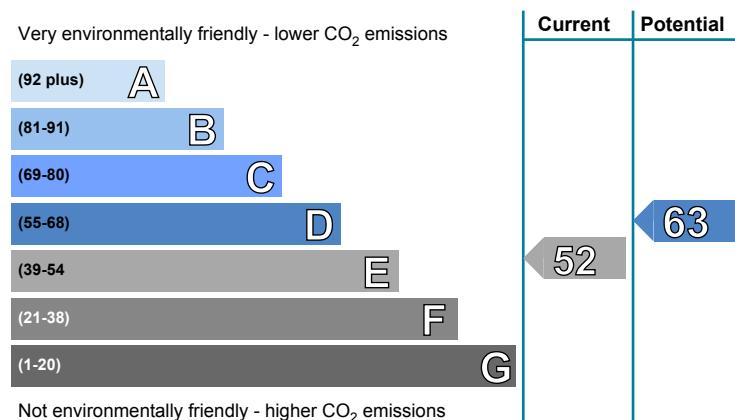
## Environmental Impact (CO<sub>2</sub>) Rating

This graph shows the effect of your home on the environment in terms of carbon dioxide (CO<sub>2</sub>) emissions. The higher the rating, the less impact it has on the environment.
