Home Report

13 Mossfield Drive Lochyside Fort William PH33 7PE

Inspected on: 30th March 2026

Prepared by:
Samuel & Partners
First Surveyors Scotland
First Floor
20 High Street
FORT WILLIAM
PH33 6AT

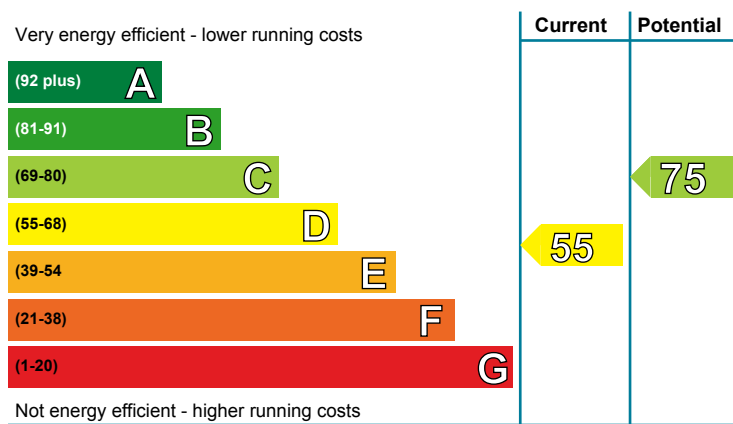
Energy Efficiency Rating

This graph shows the current efficiency of your home, taking into account both energy efficiency and fuel costs. The higher this rating, the lower your fuel bills are likely to be.

Your current rating is **band D (55)**. The average rating for EPCs in Scotland is **band D (61)**.

The potential rating shows the effect of undertaking all of the improvement measures listed within your recommendations report.
