H  
o  
m  
e

R  
e  
p  
o  
r  
t

**25 Carn Dearg Road  
Claggan  
Fort William  
PH33 6QA**

**Prepared by:**  
Samuel & Partners  
First Surveyors Scotland  
First Floor  
20 High Street  
FORT WILLIAM  
PH33 6AT

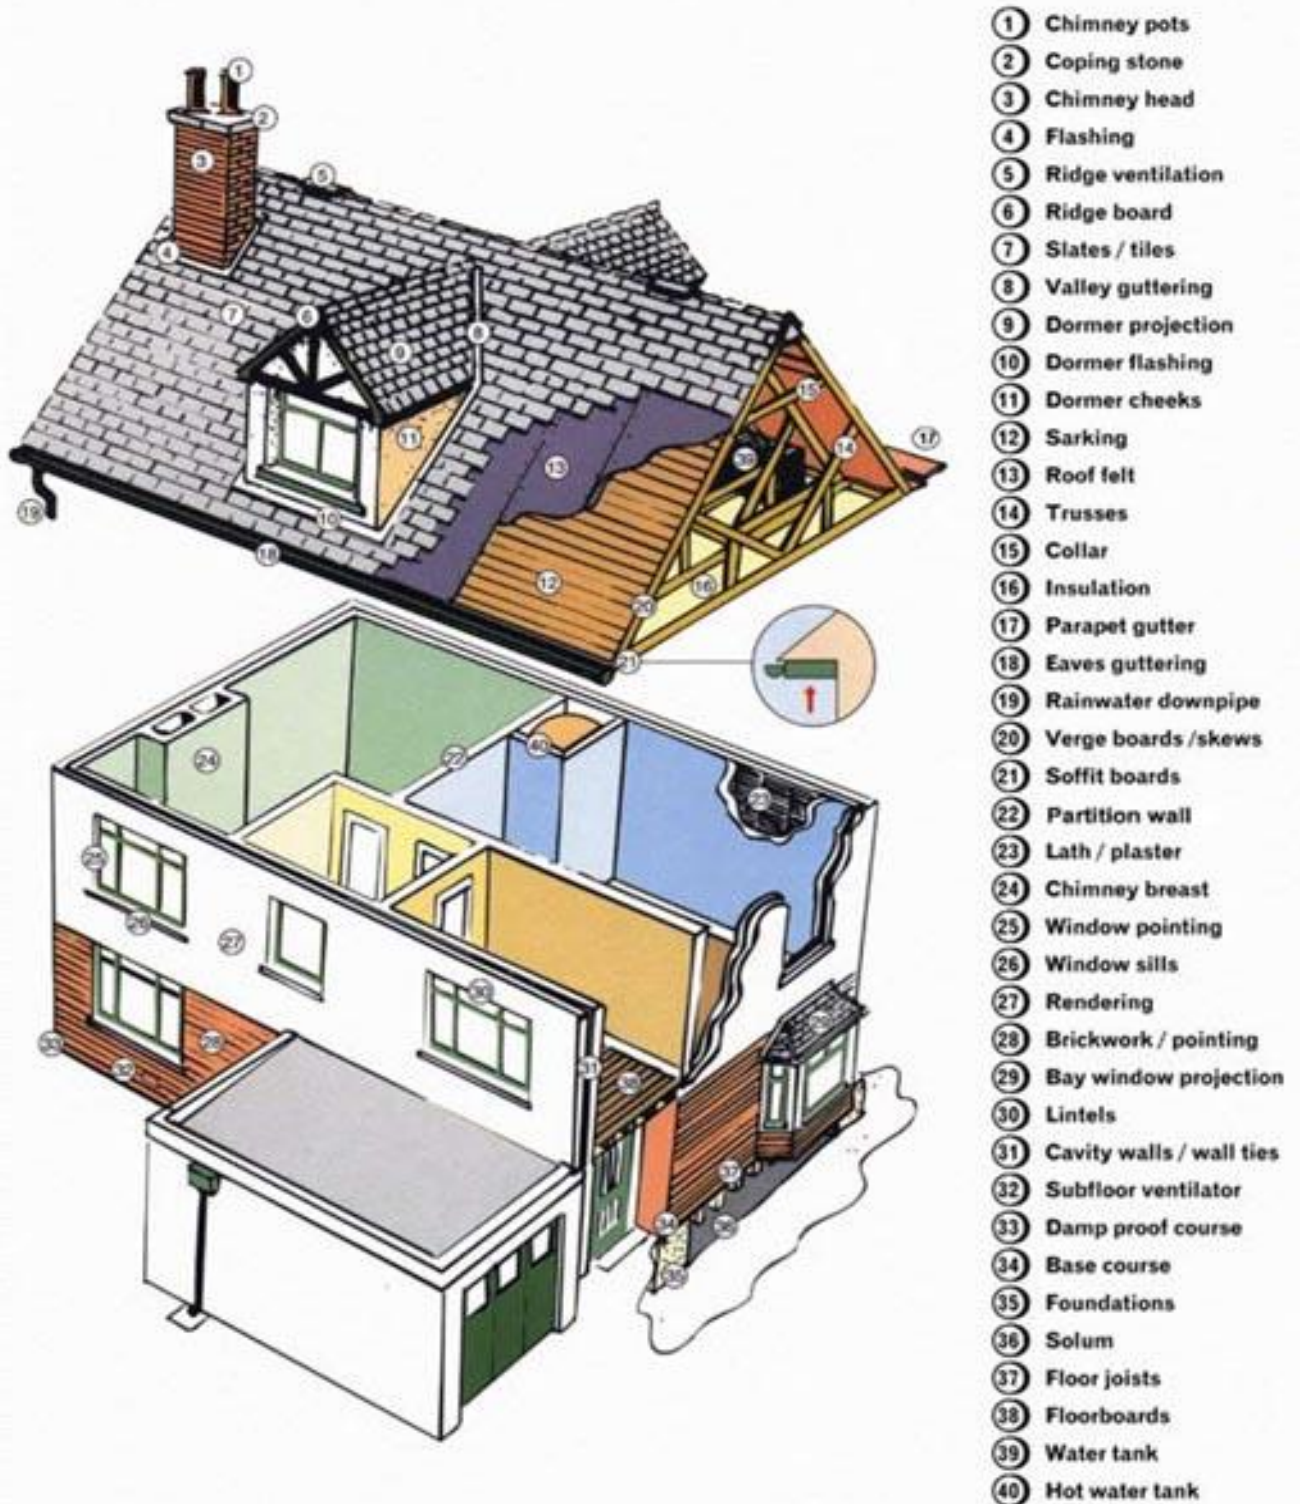
## Sectional Diagram showing elements of a typical house

Reference may be made in this report to some or all of the above component parts of the property. This diagram may assist you in locating and understanding these items.

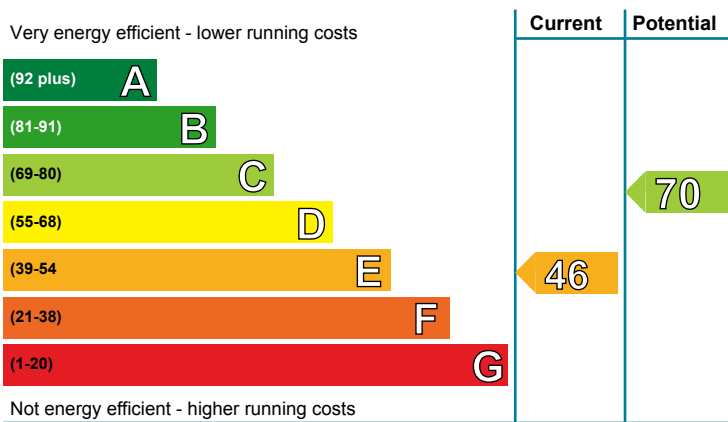
## Energy Efficiency Rating

This graph shows the current efficiency of your home, taking into account both energy efficiency and fuel costs. The higher this rating, the lower your fuel bills are likely to be.

Your current rating is **band E (46)**. The average rating for EPCs in Scotland is **band D (61)**.

The potential rating shows the effect of undertaking all of the improvement measures listed within your recommendations report.
