**Bothan Nan Creag
Roshven
Glenug
Lochailort
PH38 4NB**

Prepared by:
Samuel & Partners
First Surveyors Scotland
First Floor
20 High Street
FORT WILLIAM
PH33 6AT

1. Property Questionnaire
2. Single Survey
3. Mortgage Valuation
4. Energy Report

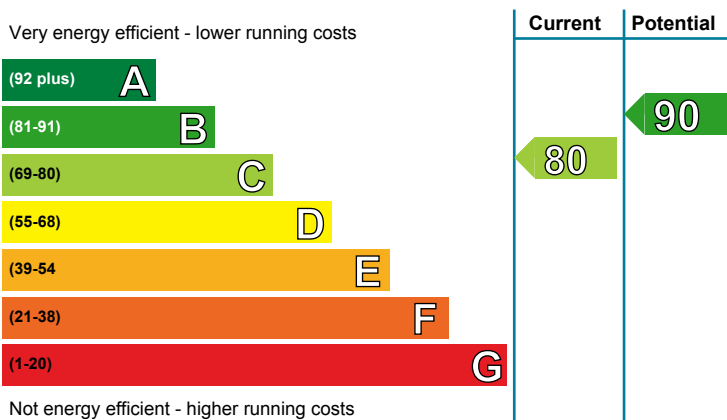
Energy Efficiency Rating

This graph shows the current efficiency of your home, taking into account both energy efficiency and fuel costs. The higher this rating, the lower your fuel bills are likely to be.

Your current rating is **band C (80)**. The average rating for EPCs in Scotland is **band D (61)**.

The potential rating shows the effect of undertaking all of the improvement measures listed within your recommendations report.
