**28 Melantee  
Claggan  
Fort William  
PH33 6PZ**

**Prepared by:**  
Samuel & Partners  
First Surveyors Scotland  
First Floor  
20 High Street  
FORT WILLIAM  
PH33 6AT

1. Property Questionnaire
2. Single Survey
3. Mortgage Valuation
4. Energy Report

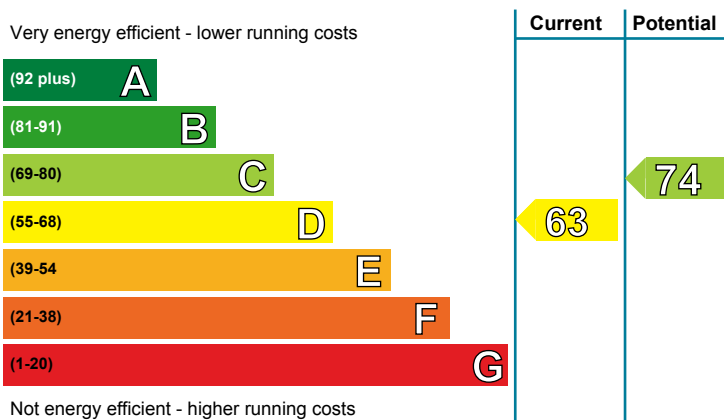
## Energy Efficiency Rating

This graph shows the current efficiency of your home, taking into account both energy efficiency and fuel costs. The higher this rating, the lower your fuel bills are likely to be.

Your current rating is **band D (63)**. The average rating for EPCs in Scotland is **band D (61)**.

The potential rating shows the effect of undertaking all of the improvement measures listed within your recommendations report.
