**Rockvale
Lundavra Road
Fort William
PH33 6RF**

Inspected on: 15th April 2026

Prepared by:
Samuel & Partners
First Surveyors Scotland
First Floor
20 High Street
FORT WILLIAM
PH33 6AT

H o m e R e p o r t - i n d e x

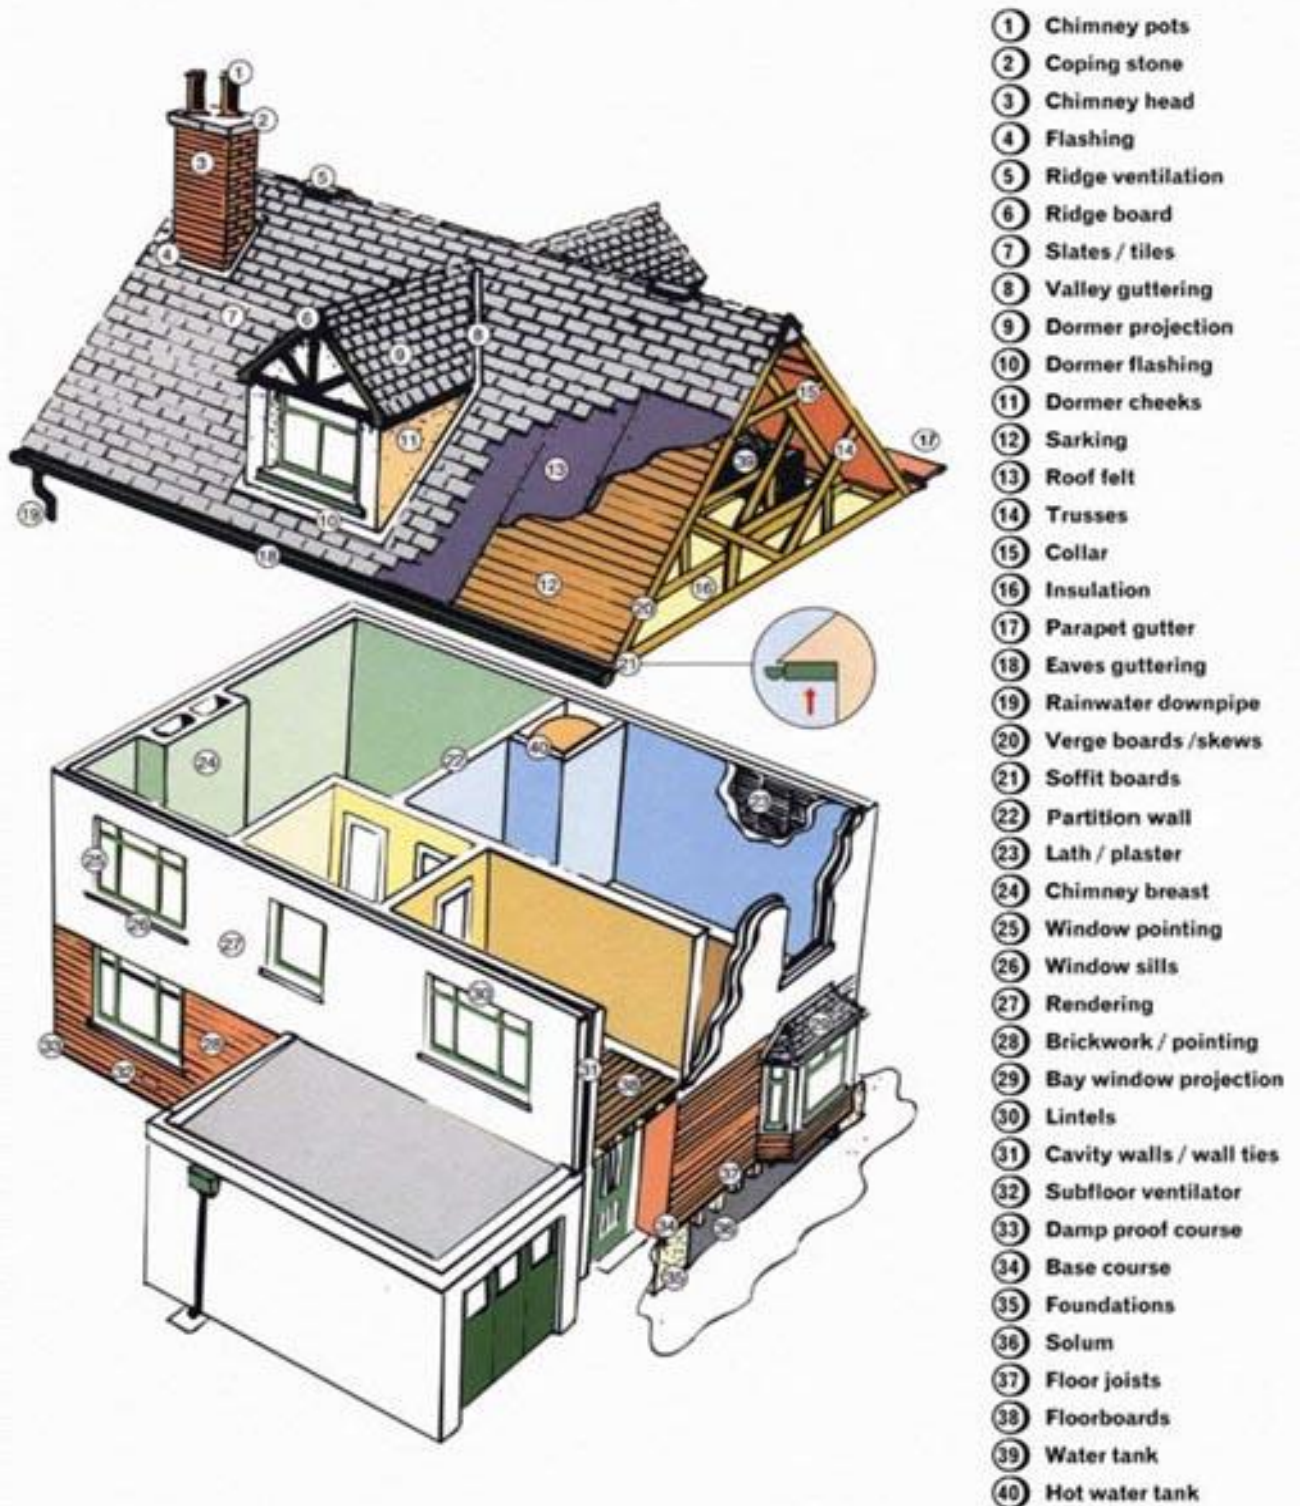
Sectional Diagram showing elements of a typical house

Reference may be made in this report to some or all of the above component parts of the property. This diagram may assist you in locating and understanding these items.

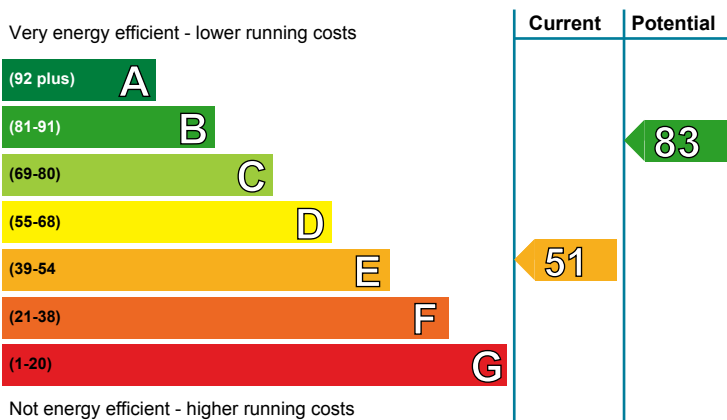
Energy Efficiency Rating

This graph shows the current efficiency of your home, taking into account both energy efficiency and fuel costs. The higher this rating, the lower your fuel bills are likely to be.

Your current rating is **band E (51)**. The average rating for EPCs in Scotland is **band D (61)**.

The potential rating shows the effect of undertaking all of the improvement measures listed within your recommendations report.

Estimated energy costs for your home for 3 years*	£5,757	See your recommendations report for more information
Over 3 years you could save*	£2,571

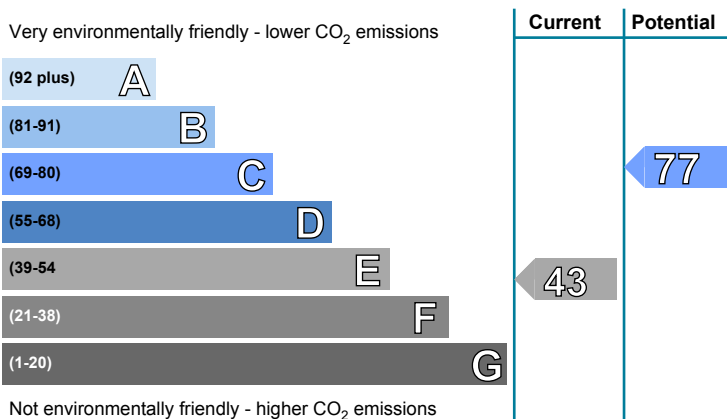
Environmental Impact (CO₂) Rating

This graph shows the effect of your home on the environment in terms of carbon dioxide (CO₂) emissions. The higher the rating, the less impact it has on the environment.
